# MSIWF 2022 Traffic Safety Research Grant

## Report of Research Results

### Title: Creating a user dynamic pedestrian traffic crossing- A case study and impact assessment in Chiang Mai University

**Primary Researcher:** Zi Liang Huang, Specialist Lecturer, Faculty of Architecture, Chiang Mai University

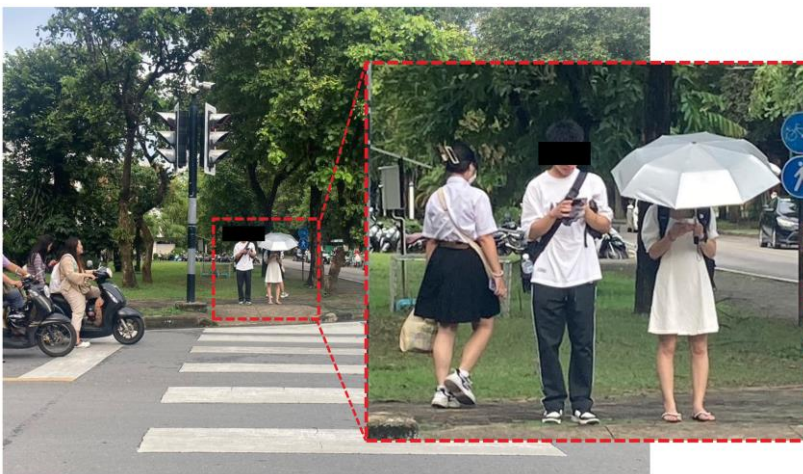
(Left image, 01) Initial observation from the site that formed the basis of the design of the SPWS. The initial site observation showed that the main cause of loss of awareness for pedestrians in Chiang Mai University was the distraction from mobile devices, both as they're approaching the traffic crossing, as well as when they're standing and waiting at the pedestrian traffic crossing, often even when the pedestrian lights have turned green and indicated a go crossing, the study observed pedestrians would sometimes not notice the signal.

As a response to the initial observations on site in Chiang Mai University, the study concluded that the system has to be a multi-sensory approach, due to the nature of the pedestrian behavior, especially in the context of a university, where pedestrians are often observed engaged in various digital devices, therefore a single sensory system might not be adequate to increase their awareness, but a multi-sensory system approach, could help to increase the chances of successful engagement, and thus the performance of the warning system.

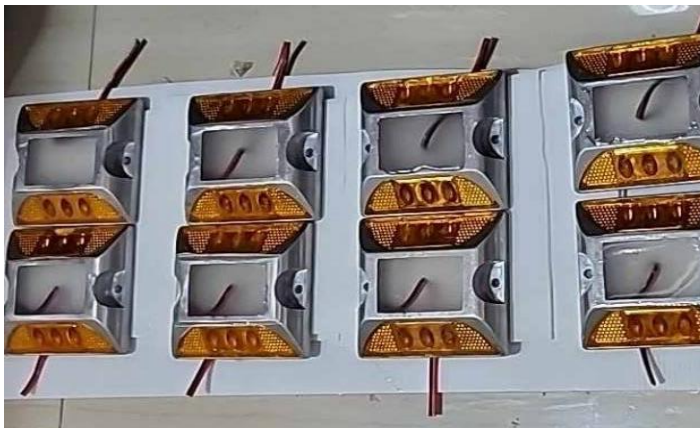
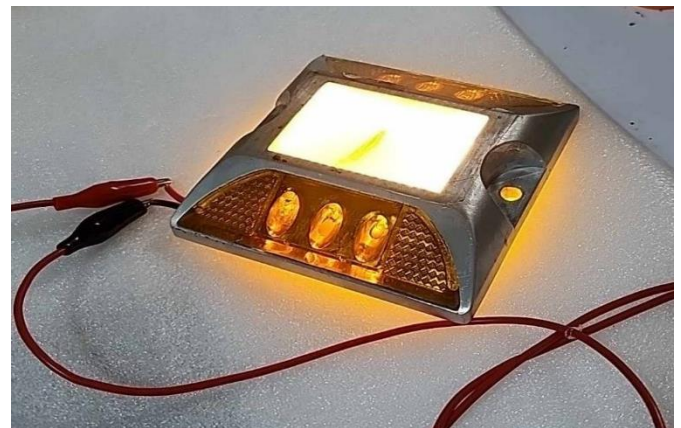
(Above left 04 and right 05) For the flashing devices, the study uses King Kong aluminum stud lights as a shell, but since they usually do not have a flashing element installed, the study commissioned an additional LED Flash unit that was custom designed and built that can fit into the shell neatly, and lastly a clear resin coat was used to encase and protect the overall unit.

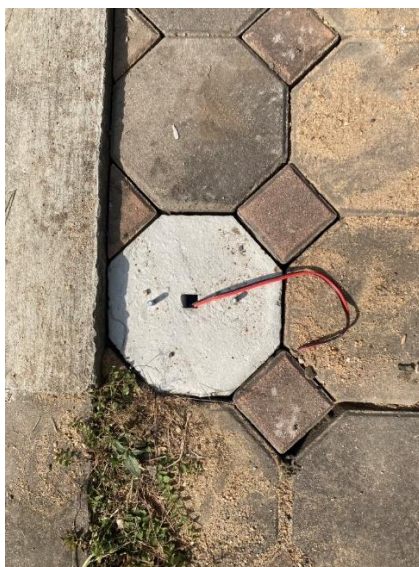
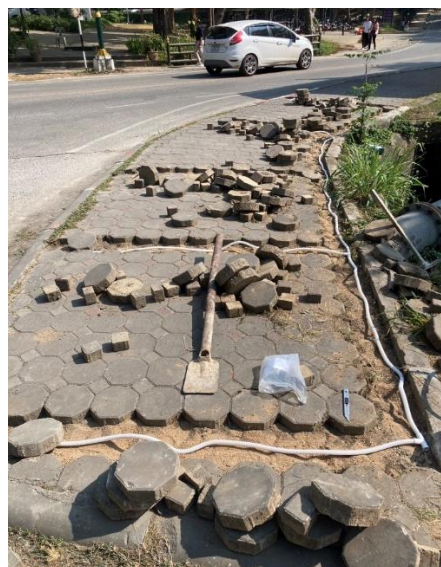
(Above left 06, center 07 and right 08 ) In order to install the flashing devices, the study attained permission from the university board to remove a series of paving stones approaching the field test site, and then a series of conduits were laid into the sand under the paving that houses the wiring system. Furthermore, a customised redesigned hexagon paving slabs was made that can house the electrical unit under each slab.
